# PROSPECT HOME INSPECTIONS

## Property Address:

1234 Your Street  
Your Town, GA 30XXX  
Your Subdivision Lot XXX

Framing and Rough – In Inspection

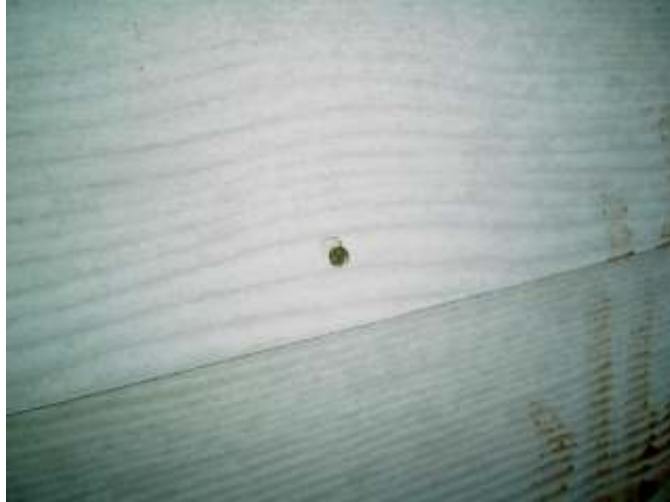
1. Brick and stone veneer siding installation had not been started at time of inspection. Note requirement for felt behind veneer sidings.
2. Some overdriven nail holes are not sealed and another nail installed beside as required by the manufacturer, such as on back at basement level. Note that failure to install a product according to the manufacturer's installation instructions often voids the warranty.
3. Door thresholds are not properly supported, such as at back of main level and basement. **IRC R501.2 Requirements.** "Floor construction shall be capable of accommodating all loads according to R301 and of transmitting the resulting loads to the supporting structural elements."
4. Window on front of garage has a broken flange.
5. Window on front of garage has staple shot through the exposed finish window components.

**Overdriven nail in siding not properly repaired**

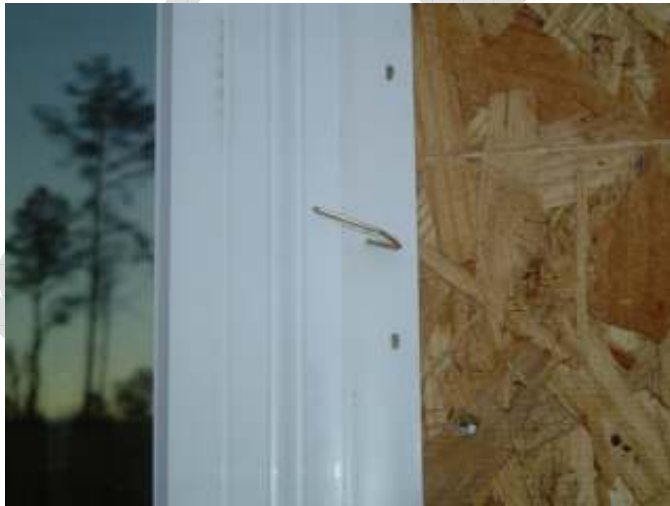
**Window stapled through exposed finish**

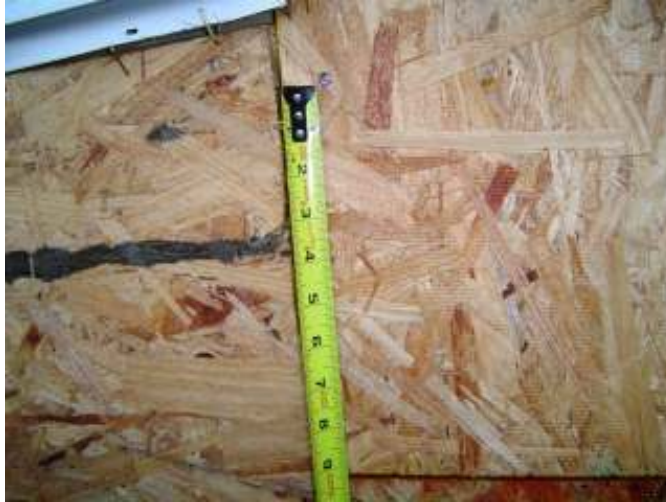
6. OSB sheathing is nailed as much as nine inches or more on center in several places where visible. **IRC TABLE R602.3(1)** requires 6d common nails at 6 inches on center along edges of structural wall panels.

**Example of incorrect nailing on OSB sheathing**

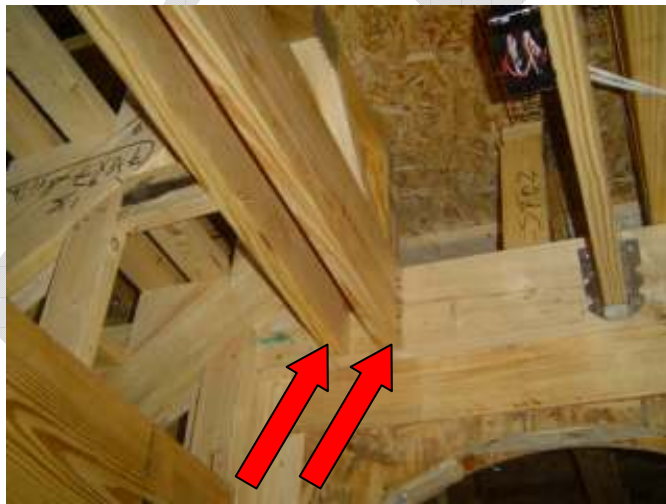
1. Some ceiling joists do not have any bearing on ends, such as main level hallway (near half bath) . **IRC R801.2 Requirements.** "Roof and ceiling construction shall be capable of accommodating all loads imposed according to R301 and of transmitting the resulting loads to the supporting structural elements." **IRC R802.6 Bearing.** "The ends of each rafter or ceiling joist shall have not less than 1-1/2 inches (38 mm) of bearing on wood or metal and not less than 3 inches (76 mm) on masonry or concrete."

**Examples of ceiling joists without proper bearing on ends**

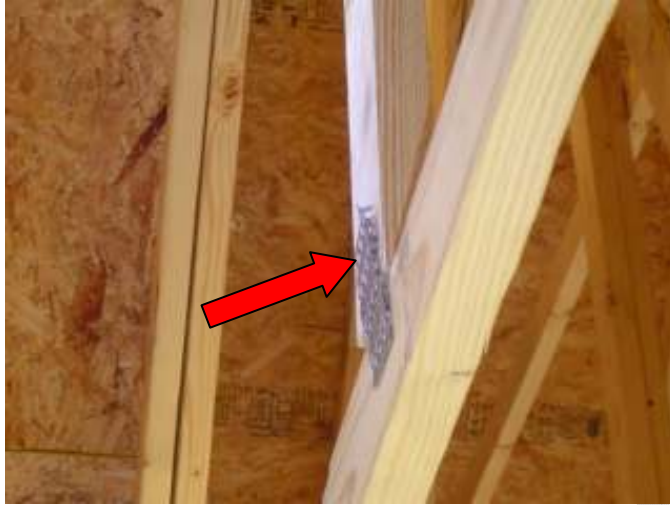
3. Truss plates are pulled loose at bottom of vertical chord of truss above entry foyer (first truss from outside wall). **IRC R802.10.4 Alterations to trusses.** "Truss members shall not be cut, notched, drilled, spliced or otherwise altered in any way without the approval of a registered design professional. Alterations resulting in the addition of load (e.g., HVAC equipment, water heater) that exceeds the design load for the truss shall not be permitted without verification that the truss is capable of supporting such additional loading."

**Damaged truss tie plate**

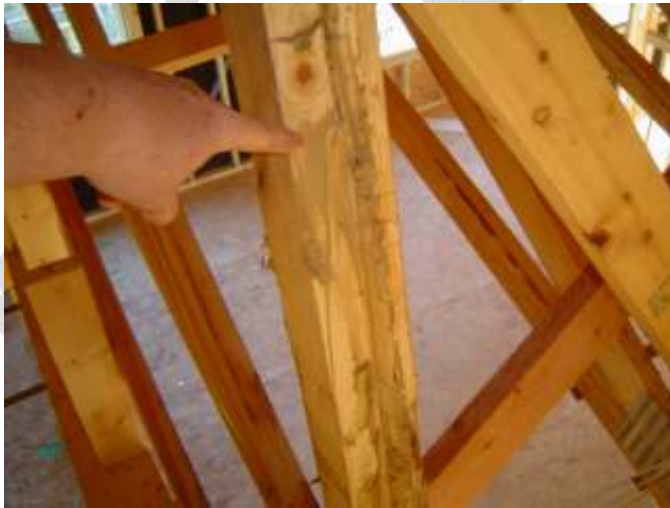
5. Vertical member at center of fourth truss from left side is badly cracked. Field repair does not conform to repairs generally found when designed by a professional engineer. Refer to **IRC R802.10.1** quoted above.

6. Near vertical member at center of sixth truss from left side is badly cracked. Field repair does not conform to repairs generally found when designed by a professional engineer. Refer to **IRC R802.10.1** quoted above.

**Improperly repaired cracked truss member**

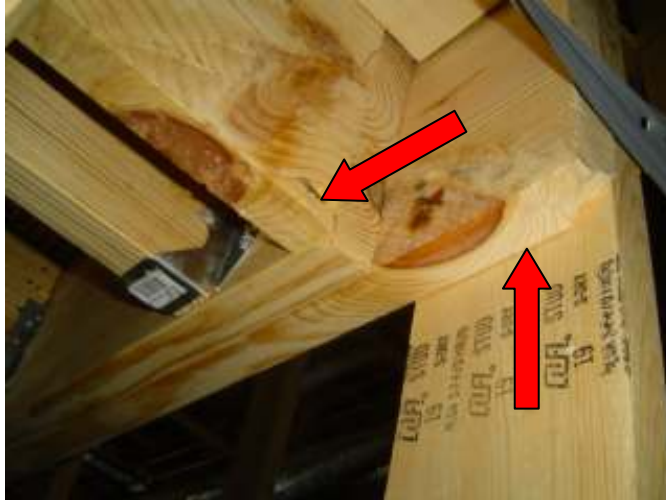
3. Some ends of band joists under stair landings (both levels) do not have any bearing. **IRC R502.6 Bearing.** “The ends of each joist, beam or girder shall have not less than 1.5 inches (38 mm) of bearing on wood or metal and not less than 3 inches (76 mm) on masonry or concrete except where supported on a 1- inch-by-4-inch (25.4 mm by 102 mm) ribbon strip and nailed to the adjacent stud or by the use of approved joist hangers.”

**Band and joist no bearing on ends example**

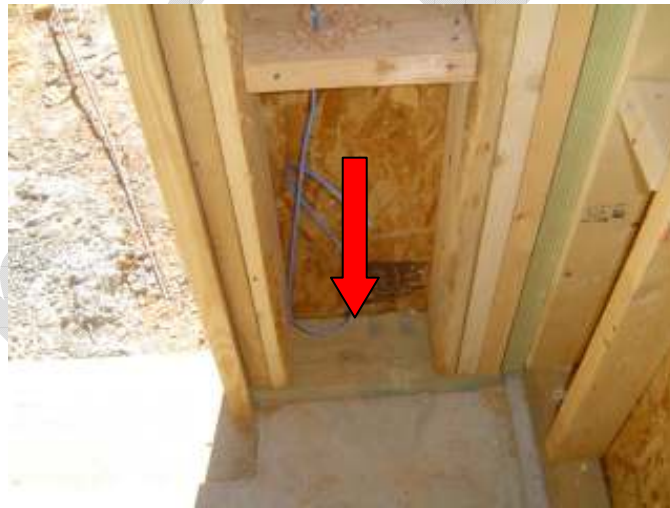
7. Anchor bolts are not installed in walls on each side of the garage door opening. Refer to **IRC R602.10.5 Exception (Georgia Amendment)** quoted above.
8. Note that inspector was unable to confirm nailing pattern for OSB on exterior of garage door opening. Nails should be installed in a three inch grid pattern. Recommend to verify with builder that sheathing is correctly nailed. Refer to **IRC R602.10.5 Exception (Georgia Amendment)** quoted above.
9. Due to above deficiencies, I recommend further evaluation by a registered professional engineer with training and experience in repairs of foundations, framing, etc. for wood framed structures. The engineer should provide a sealed letter either approving existing installation or drawings for corrective action needed. The engineer should verify that repairs are properly installed.

**Anchor bolts missing at walls in garage example**

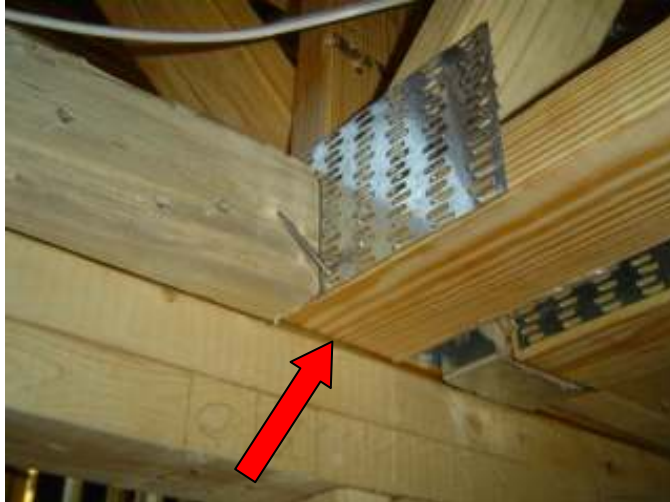
1. Ends of small truss above half bath do not have proper bearing. **IRC R501.2 Requirements.** “Floor construction shall be capable of accommodating all loads according to R301 and of transmitting the resulting loads to the supporting structural elements.” Refer to **IRC R502.6** quoted below.

**Floor truss no bearing on end**

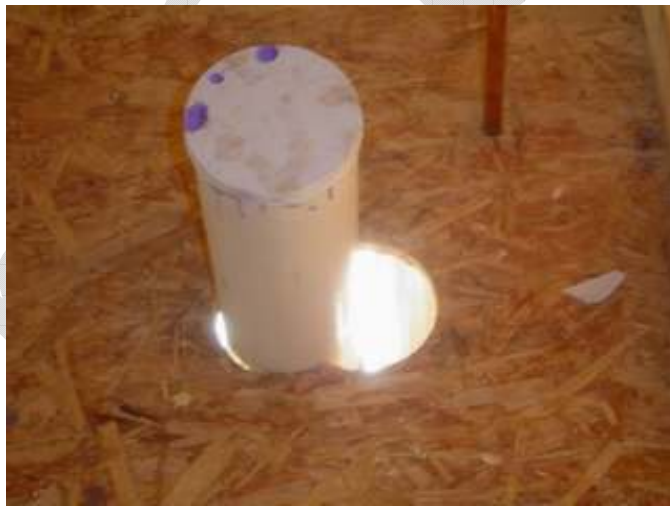
1. Fireblocking was not installed in numerous places, such as at electrical cables, water and drain piping, etc. at time of inspection. **IRC R602.8 Fireblocking required.** “Fireblocking shall be provided to cut off all concealed draft openings (both vertical and horizontal) and to form an effective fire barrier between stories, and between a top story and the roof space. Fireblocking shall be provided in wood-frame construction in the following locations:

**Fireblocking missing at plumbing penetration example**

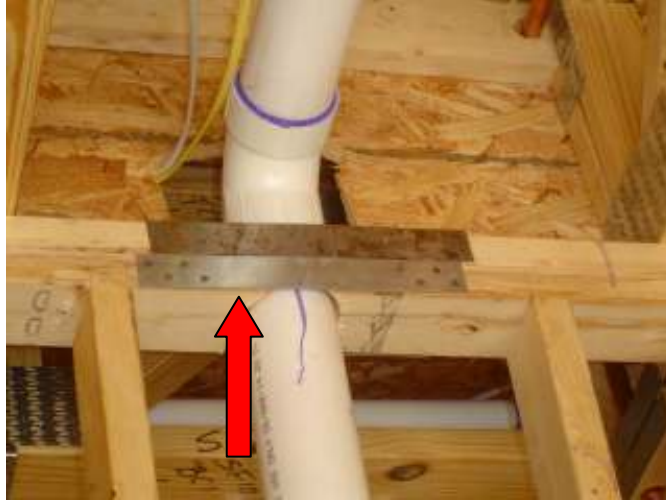
1. Shield plates for piping are incorrect type. They do not extend two inches below the top plate and two inches above the bottom plate as required. **IPC 305.8 Protection against physical damage.** “In concealed locations where piping, other than cast-

**Shield plate does not extend two inches below top plate example**

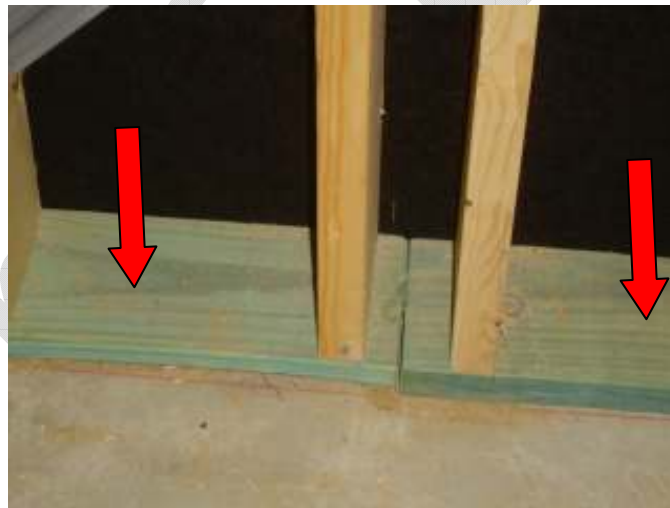
1. Foundation anchors are wall straps that are improperly installed in some areas. Anchors are not installed within 12 inches of ends of plate sections. Several do not have any nails installed. Note that shot anchors are installed, but do not provide equivalent anchorage as the straps. **IRC R403.1.6 Foundation anchorage.** “When braced wall panels are supported directly on continuous foundations, the wall wood sill plate or cold-formed steel bottom track shall be anchored to the foundation in accordance with this section. In Seismic Design Categories D<sub>1</sub> and D<sub>2</sub>, the additional anchorage requirements of R602.11.1 shall apply for wood framing. In Seismic Design Categories D<sub>1</sub> and D<sub>2</sub> where continuous wood foundations in accordance with R404.2 are used, the force transfer shall have a capacity equal to or greater than the connections required by R602.11.1 or the braced wall panel shall be connected to the wood foundations in accordance with the braced wall panel-to-floor fastening requirements of Table R602.3(1). The wood sole plate at exterior walls on monolithic slabs and wood sill plate shall be anchored to the foundation with anchor bolts spaced a maximum of 6 feet (1829 mm) on center. Anchor bolts shall also be located within 12 inches (305 mm) from the ends of each plate section. In Seismic Design Categories D<sub>1</sub> and D<sub>2</sub>, anchor bolts shall also be spaced at 6 feet (1829 mm) on center and located within 12 inches (305 mm) from the ends of each plate section at interior braced wall lines when required by R602.10.9 to be supported on a continuous foundation. Bolts shall be at least 1/2 inch (12.7 mm) in diameter and shall extend a minimum of 7 inches (178 mm) into masonry or concrete. Interior bearing wall sole plates on monolithic slab foundations shall be positively anchored with approved fasteners. A nut and washer shall be tightened on each bolt to the plate. Sills and sole plates shall be protected against decay and termites where required by R322 and R323. Cold-formed steel framing systems shall be fastened to the wood sill plates or anchored directly to the foundation as required in R505.3.1 or R603.1.1.

**Foundation anchors not installed within 12 inches of ends of plate sections**

EXCEPTION: Foundation anchor straps, spaced as required to provide equivalent anchorage to 1/2-inch-diameter (12.7 mm) anchor bolts.”  
Note that another type of anchor, such as shot anchors will be needed to properly secure the plate to the foundation. The new type will need to be installed according to the manufacturer’s instructions or obtain a letter from a registered professional engineer or the manufacturer’s representative approving any combination of different types of anchors.
